DEFLATION SYSTEM FOR OTR'S BOLT-TOGETHER ALUMINUM WHEELS

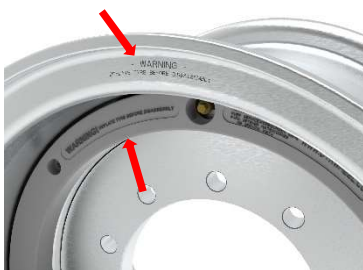
Picture A.

- WARNING messages placed on outer wheel half, in-line with the port style valve stem and the nut cover ring (2-locations). **PICTURE A.**
- Nut-cover ring provides information how to access servicing instructions. **PICTURE B.**
- Nut-cover ring secured in place in front of the nuts to prevent personnel from accidentally loosening nuts while removing the wheel from the hub. **PICTURE C.**
- Two port plugs installed in front of the nut cover ring. these plugs seal two venting ports that located in the inner wheel half.
